Army Lodging Wellness Recommendation

Final Submittal - Fort Myer

February 12, 2004

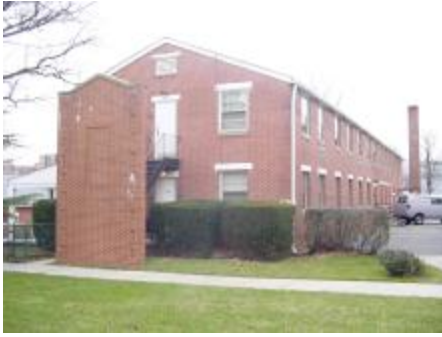
*Building 48
Fort Myer
Washington, D.C.*

Building 48, constructed in 1944, is a 2-story wood structure housing 13 family suites of varying room size and configuration. This facility does not meet Lodging standards and cannot be reconfigured without significant reconstruction. To renovate Building 48 to the new standards and configuration will exceed 50% of the replacement cost.

Because the Renovation to Replacement Cost Ratio is greater than 50.00%, renovation of Building 48 is not recommended.

Our recommendation is to remove Building 48 from the Lodging inventory, allowing the installation to determine an alternate use for this facility. This facility will be removed from the Fort Myer Wellness Solution and Lodging Master Plan.

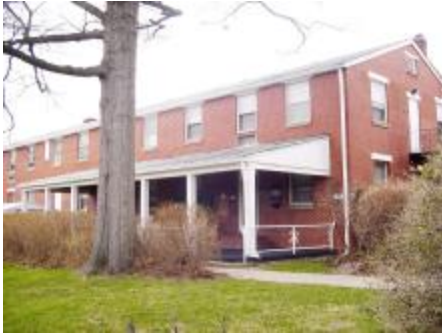
Building 48
View of west elevation

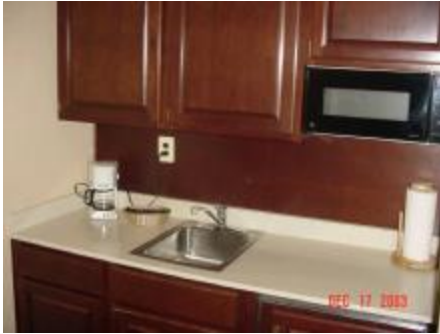
Building 48
View of guest room kitchen

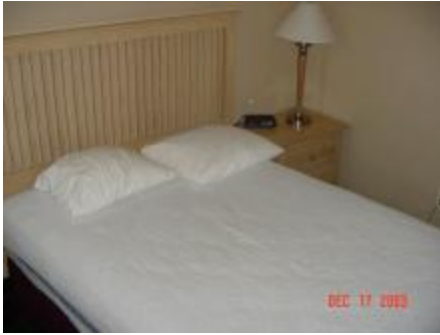
- Analysis: Guest Rooms: The hard goods consist of a head board, night stand, dresser, easy chair, end table, desk and entertainment shelf unit and sofa. All are in fair condition. Soft goods consists of drapes and blinds on the windows, TV, mattress and box springs and bed coverings. All are in fair condition.
- Recommendation: Replace all hard and soft goods in guest rooms.

Building 48
View of typical bedroom

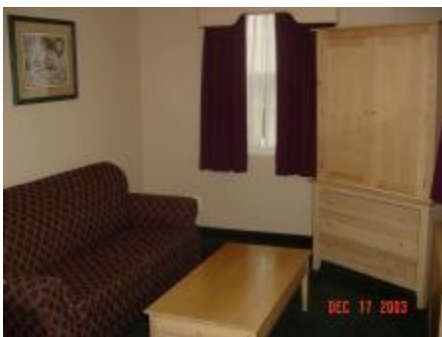
Building 48
View of typical living area

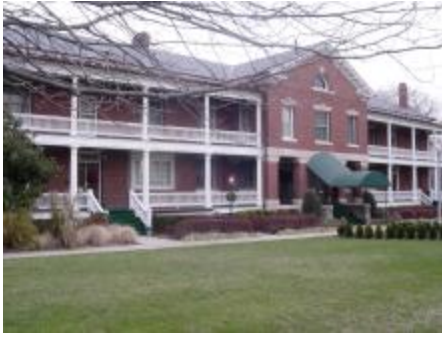
*Building 50
Fort Myer
Washington, D.C.*

• Condition Assessment Cost	\$1,562,601
• Replacement Cost	\$2,983,929
• Condition Assessment to Replacement Cost Ratio	52.37%

Because the Condition Assessment to Replacement Cost Ratio is greater than 50.00%, repair of Building 50 is not recommended.

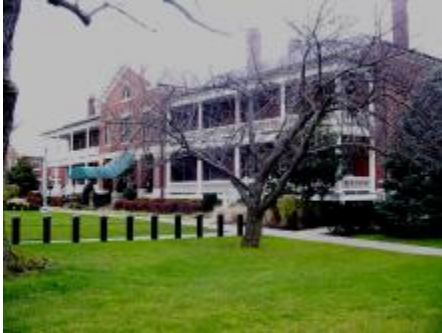
Building 50
View from northeast

- Analysis: The original roof is pitched and consists of wood trusses and wood decking supporting a slate tile covering, and is in good condition. Portions of the building have a flat built up roof in excess of twenty years of age that is in poor condition. There are gutters external to the roof that are leaking, resulting in damage to the soffit and fascia.
- Recommendation: Replace the flat roof and gutters. Repair the damaged soffit and fascia.

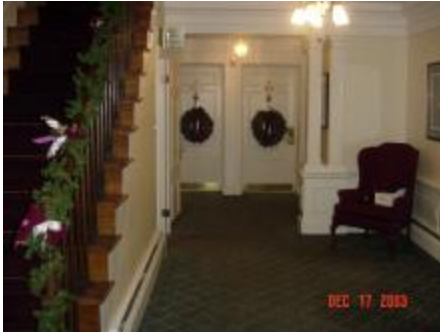
Building 50
View of guest corridor

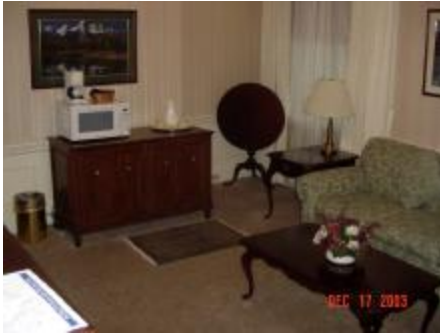
Building 50
View of typical guest living area

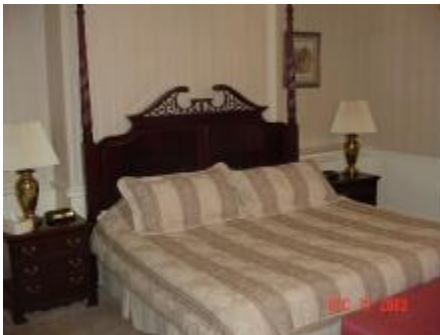
Building 50
View of typical guest bedroom
